**DEPARTMENT OF TRANSPORTATION**

Contract #: 04-0120F4Cty: SF/ALA Rte: 80 PM: 13.2/13.9File #: 78.28**WELDING INSPECTION REPORT****Resident Engineer:** Casey, William**Address:** 333 Burma Road**City:** Oakland, CA 94607**Report No:** WIR-030075**Date Inspected:** 25-Sep-2013**Project Name:** SAS Superstructure**OSM Arrival Time:** 700**Prime Contractor:** American Bridge/Fluor Enterprises, a JV**OSM Departure Time:** 1530**Contractor:** Steward Machine Co.**Location:** Birmingham, AL**CWI Name:** Fred Hudson (Cert. #01061501)**CWI Present:** Yes No**Inspected CWI report:** Yes No N/A**Rod Oven in Use:** Yes No N/A**Electrode to specification:** Yes No N/A**Weld Procedures Followed:** Yes No N/A**Qualified Welders:** Yes No N/A**Verified Joint Fit-up:** Yes No N/A**Approved Drawings:** Yes No N/A**Approved WPS:** Yes No N/A**Delayed / Cancelled:** Yes No N/A**Bridge No:** 34-0006**Component:** E2 Shear Key Anchorages**Summary of Items Observed:**

## WELDING INSPECTION REPORT

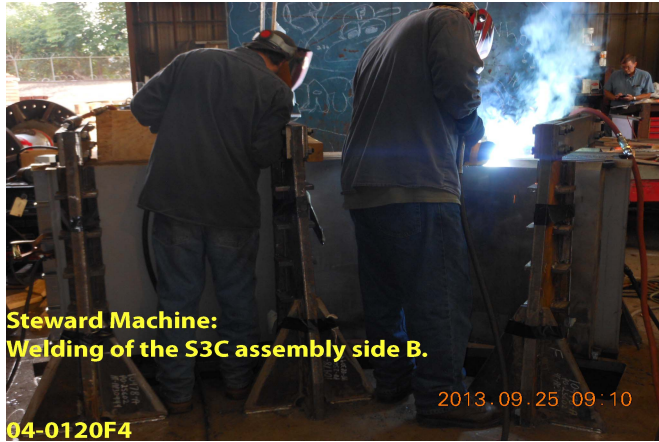
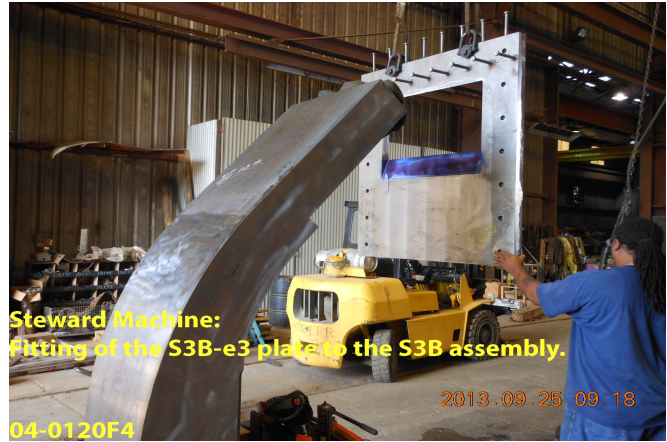
The assembly was observed being fitted with the S3B-e3 plate. After the plate was fitted the root pass for the f3 plate was welded on side A and tested with MPT by the QC Inspector. The welding was performed by Ben Rhodes utilizing WPS P2-W128-b for FCAW-G in the 1G position. The welding parameters were observed adjusted and monitored by Certified Welding Inspector (CWI) Fred Hudson (Cert. #01061501) who was onsite with the WPS as required by contract documents. The welding parameters were measured to be 30volts/300amps using 1/16" Class E70T-1 filler and 100% CO2 at 40cfm.

Welders John Ray (#469) and Ben Rhodes #481 were observed welding the assembly side B cover passes utilizing Welding Procedure Specification (WPS) P2-W126-B for Flux Core Arc Welding-Gas Shielded (FCAW-G) in the 1G position. The welding parameters were observed adjusted and monitored by Certified Welding Inspector (CWI) Fred Hudson (Cert. #01061501) who was onsite with the WPS as required by contract documents. The welding parameters were measured to be 30volts/300amps using 1/16" Class E70T-1 filler and 100% CO2 at 40cfm. The assembly as noted above includes plates S3C-e4, S3C-f4, S3C-g4, S3C-d4, S3C-c4, S3C-h4, S3C-b4 & S3C-a4.
